600 Parker Street Street, Boston, MA

Owner: Wentworth Institute of Technology, Boston, MA

Timeline: August - December 2015

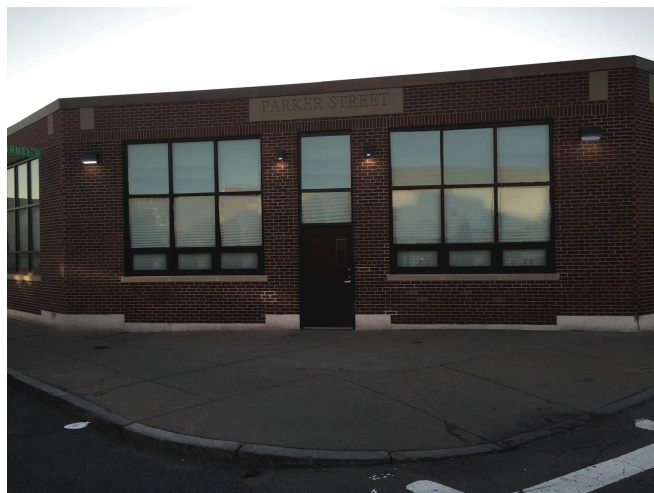
Abbot's evaluated the building and identified the following major deficiencies:

- The brick masonry was extremely dirty
- The window sills were deteriorated and in some cases non-existent
- Brick above the windows to the roof had deflected and was no longer in plane with walls
- The windows were non-existent and filled with concrete block

Based upon this comprehensive evaluation, Abbot performed the following sequence of repairs:

- All brick was power washed with a restoration cleaner to remove existing dirt, and paint was removed from bottom of perimeter of building to provide for a natural brick appearance
- All brick joints were repointed
- All of the bricks were removed from the top of the windows to the roof line, and entirely rebuilt using new matching brick
- The concrete blocks were removed from all windows
- New pre-cast concrete window sills were fabricated and installed to replace deteriorated and non-existent sills,
- New key stones were installed in the parapet corners to decorate the walls
- New energy efficient windows with security screens were installed
- The foundation and balance of the existing poured concrete was coated with an elastomeric material to improve the building's appearance
- Finally, a new precast front sign was fabricated to match the original sign
