## Abbot Building restores façade of 8-story 389 Congress St.

**Boston, MA** Abbot recently restored the façade of an 8-story mixed-use high-rise building at 389 Congress St. in Boston's historic Fort Point Channel Landmark district. Built in 1907, the building was originally known as the Boston Wharf Company Building and was used for manufacturing and warehousing. The building is constructed of poured steel reinforced concrete with brick panels under the windows.

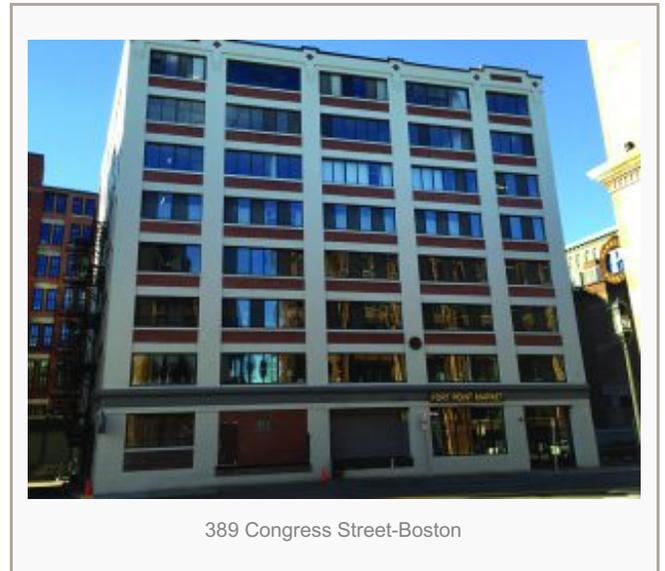
389 Congress Street-Boston

Over the years, the rusting of the reinforced steel had caused a significant portion of the concrete to debond away from the building. Recently, the city issued a violation to the owner because of danger to pedestrian and vehicle traffic under the high-rise ordinance. The owner hired an architectural firm (Gorman Richardson Lewis) to evaluate the problem and prepare specifications to repair the façade on all four sides of the building.

One of the complexities of the repair process was that the demolition of concrete created large cavities and exposed severely deteriorated reinforcing steel. To remedy this issue, it was determined that the new steel had to be anchored into the cavities. Abbot used #3 and #4 corrosion resistant epoxy coated rebar that was epoxy anchored into the cavities to reinforce the new concrete. The material chosen for the repair was a new single-component, self-leveling, pourable polymer-modified concrete mix (Sikacrete 211 SCC Plus).

Following the demolition and installation of steel reinforcing rods, Abbot formed the cavities and installed keyways into the forms to allow a pathway for the new pourable concrete. After the concrete had cured, the forms were removed and very little finishing was needed due to the self-leveling feature of the SikaCrete product. A total of nearly 4,500 s/f of SikaCrete was used in this process covering about 35% of the building.

Upon completion of concrete repair on the individual elevations, Abbot coated the walls with SikaGard 550W Elastocolor, a high performance elastomeric crack/bridging coating. The Fort Point Channel Landmark District commission chose the color based on a historical photo of building.
