Abbot Building Restoration Company completes work on façade at 1-5 Peterborough Street

1-5 Peterborough Street - Boston, MA

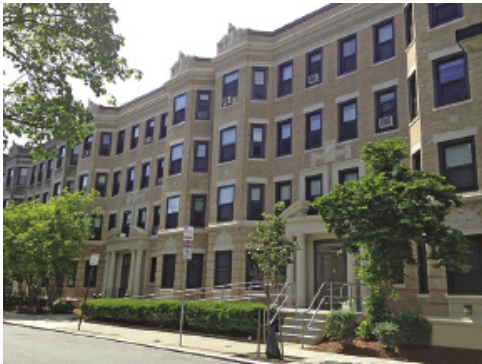
Abbot Building Restoration Company recently restored the façade of a 4-story brick and pre-cast stone residential building at 1-5 Peterborough St. in the Fenway section of the city. The building had experienced severe deterioration over the years, particularly to the pre-cast stone headers, sills, lower bands, and upper dental bands. To address the situation, the owner contracted the consulting firm of Garofalo Design Associates (Boston, MA) to oversee the restoration. The general repair contract was awarded to Landmark Structures Corporation (Woburn, MA) who subcontracted with Abbot to perform the exterior masonry portion of the restoration.

Abbot removed and replaced the damaged pre-cast stones and bands with specially fabricated pre-cast stones to match the profiles of the existing stonework. Then Abbot coated all of the pre-cast stones with an elastomeric coating to provide a uniform appearance. To finish the restoration, Abbot repointed sections of the brick façade to match the original color while carefully blending the mortar to the adjoining surfaces that were not repointed.
