Abbot Building Restoration restores façade of spa building

SkinHealth spa building - Boston, MA

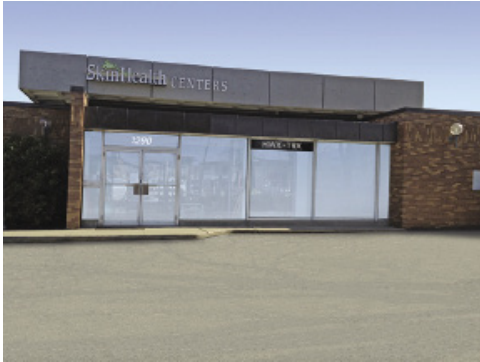
Abbot Building Restoration Company's small projects division recently restored the façade of the full service "SkinHealth" spa building located adjacent to the Healthworks Fitness Center in the city's Chestnut Hill area. Having restored the main fitness facility several years ago, Abbot was asked by the lessees to survey their spa building in the fall of 2012. Abbot's investigation indicated that the concrete band above the storefront had been stained with atmospheric dirt from the adjacent highway, and also found several areas of concrete deterioration. In addition, areas at the top of the brick wall around the perimeter of the building were stained and deteriorated.

Following the investigation, Abbot was contracted to power wash the concrete and brick masonry around entire building to remove the atmospheric staining, and to repair the concrete band above the storefront. Abbot also repaired the brick around the perimeter of the building and surrounding the windows, carefully matching the mortar color to assure a consistent appearance. To complete the restoration, Abbot capped all of the brick with bronze coated aluminum, and coated the concrete band to match the appearance of the main building.
